Building Inspection Report

XXXXXXXX XXXXX XXXXX , FI

Inspection Date:
XXX.XX, XXXX

Report Number:
XXXXXXXXXX

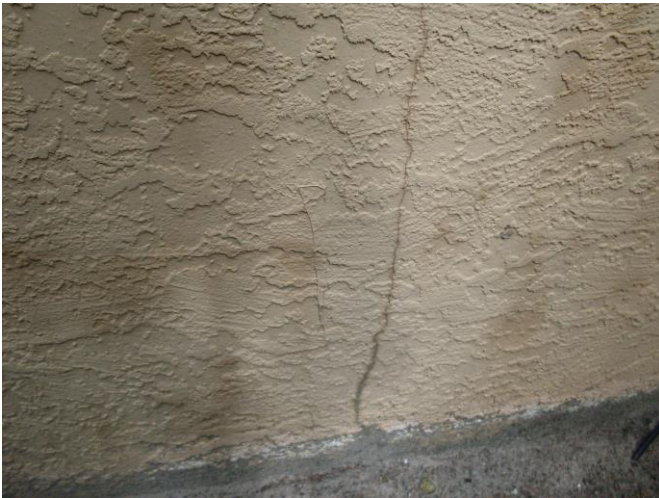
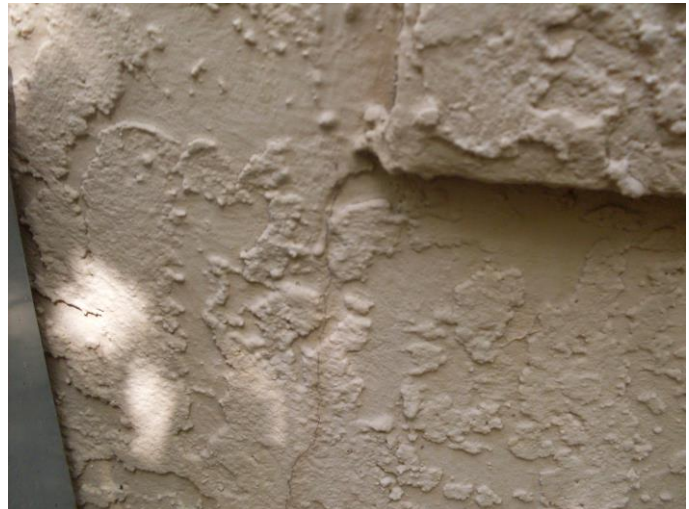
- **Major concern:** Stucco damage was found at the back right of the home.

- **Repair:** Stucco cracks in various places should be sealed. This signifies that the home has experienced typical settling.

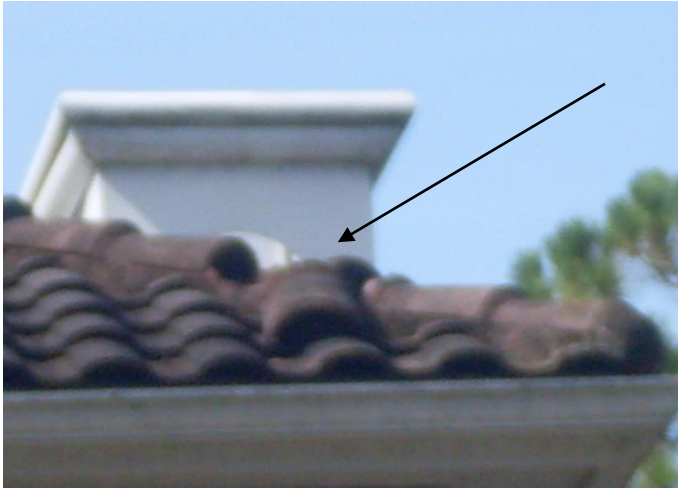
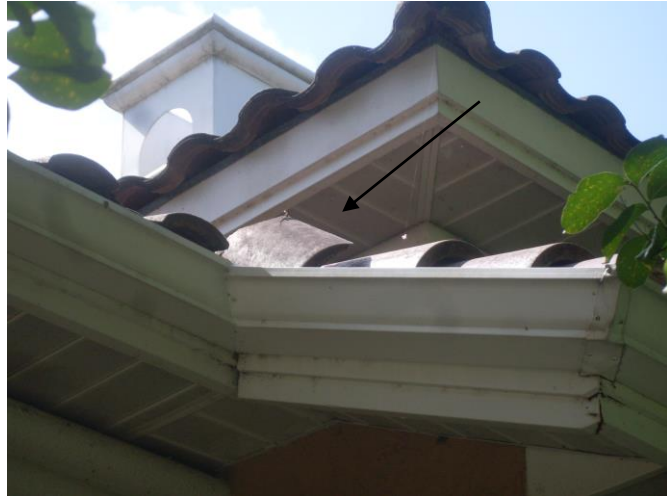
- **Major concern:** Cracked and damaged roof tiles were found in various places.

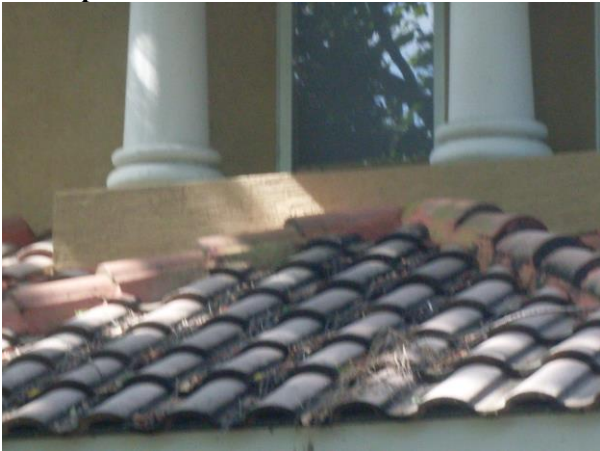
- **Repair:** Debris should be removed from the roof.

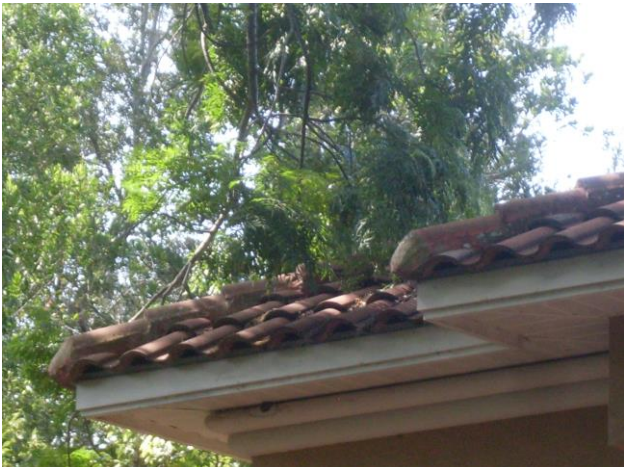
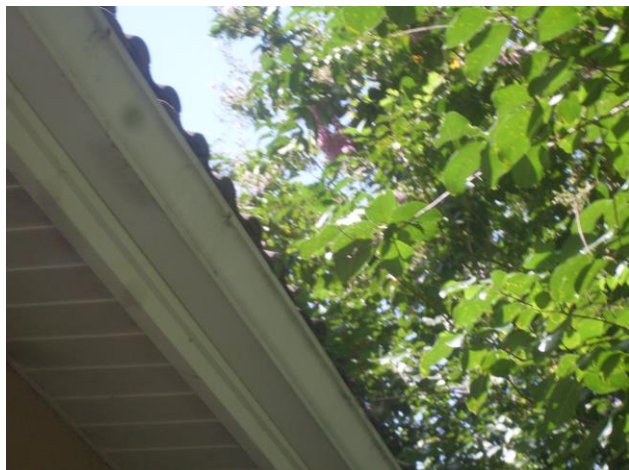
- **Repair:** The trees should be removed from the roof.

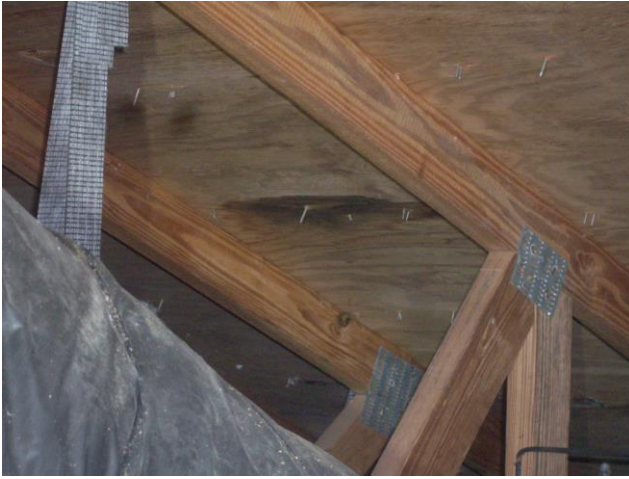
- **Monitor:** Water staining that appears to be active was found in the attic. A roofer should be consulted.

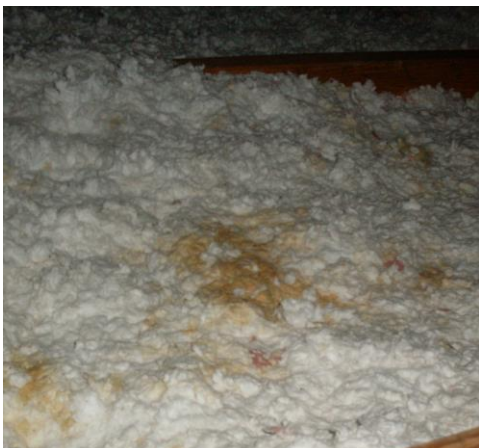
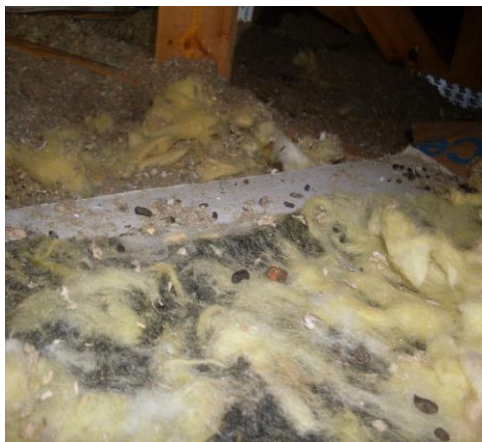
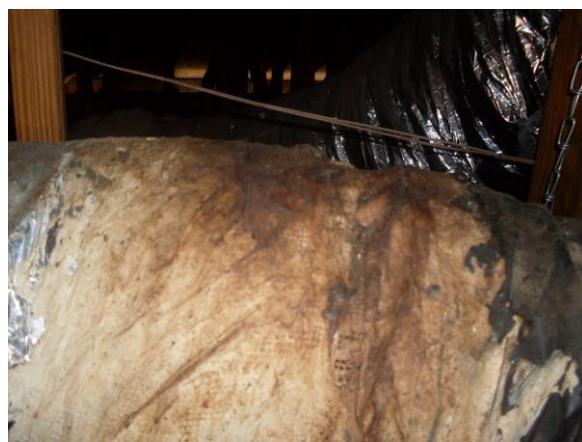
- **Repair:** An excessive amount of rodent excrement was found in the attic in multiple locations.

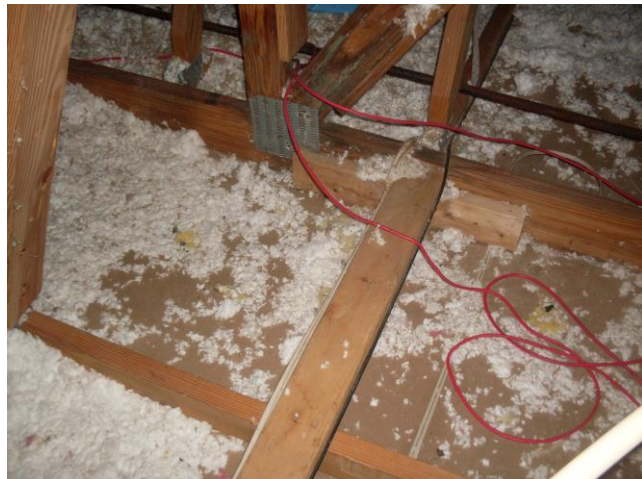
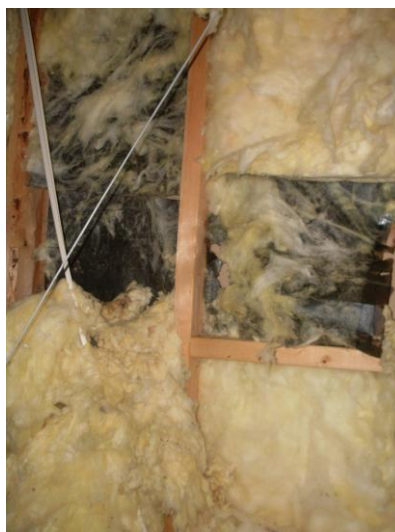
- **Repair:** The insulation is low in various places.

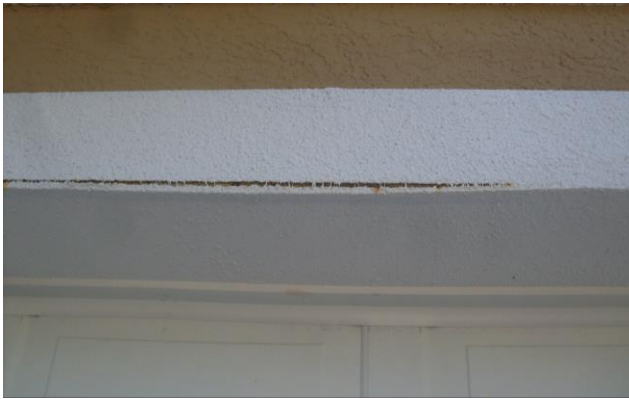
- **Repair:** Rusting, falling stucco corner bead was found at the garage.

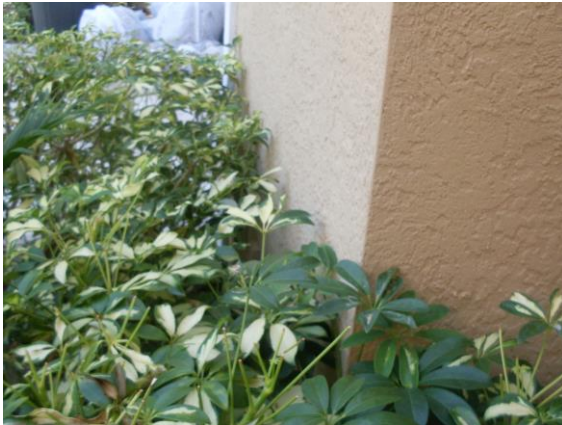
- **Repair:** The brush should be cut back from the home.

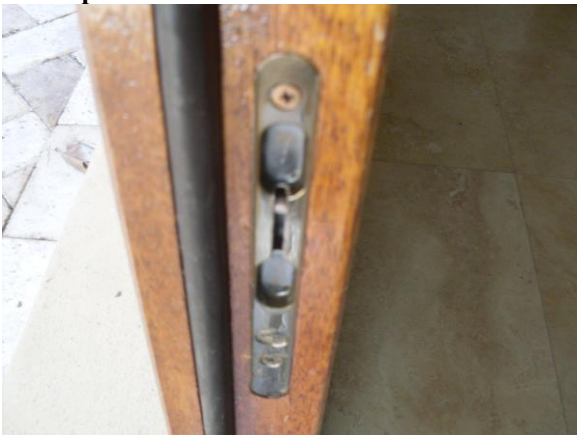
- **Repair:** The front French door bottom lock is missing.

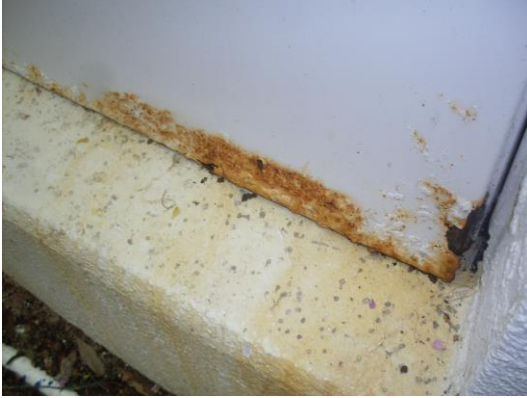
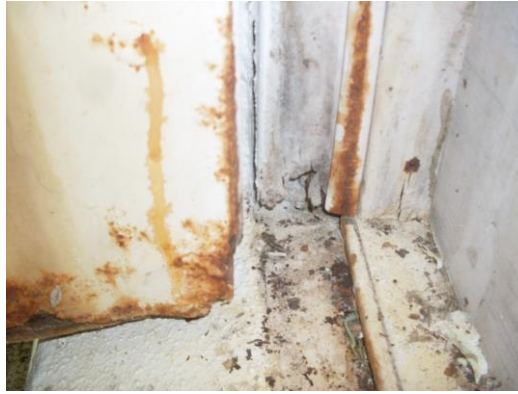
- **Repair:** The doorbell does not work.
- **Repair:** The right side of the home AC closet door encasing is decayed.

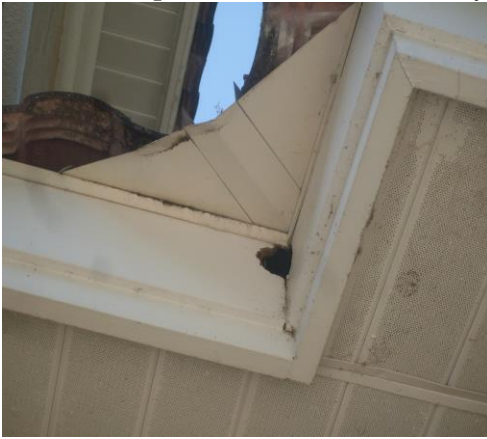
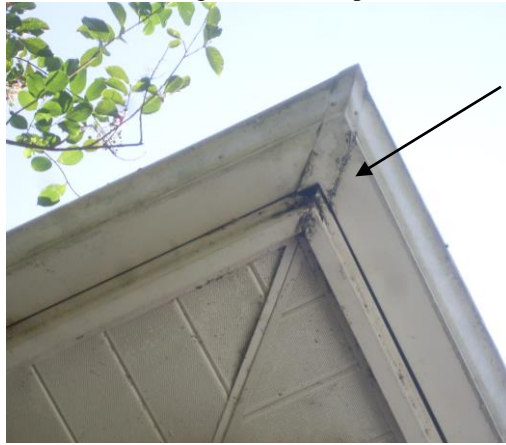
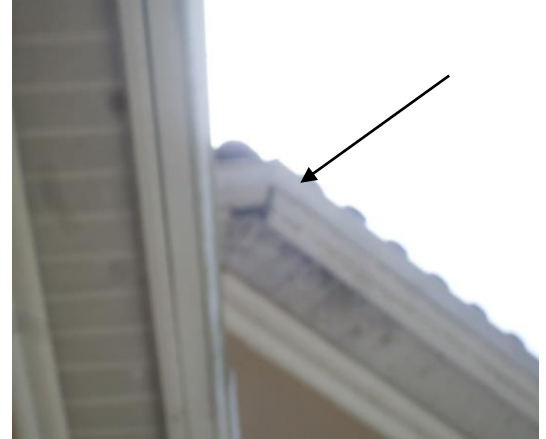
- **Repair:** The fascia board is decayed and rodent damaged in various places.

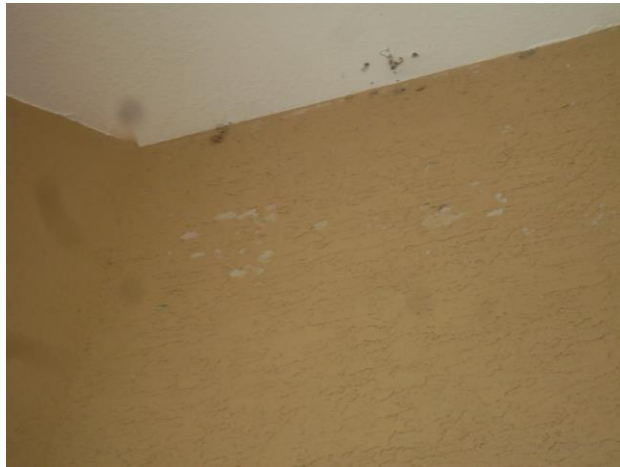
- **Repair:** The back porch needs paint/ceiling.

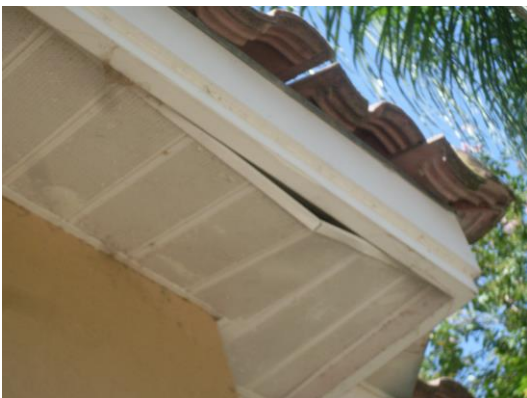
- **Repair:** The soffit on the right front is hanging.

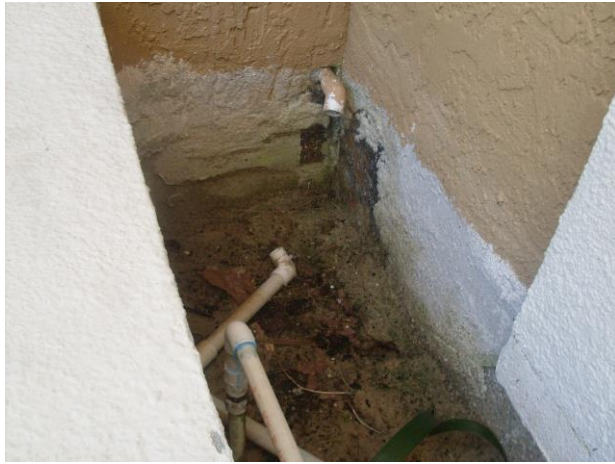
- **Repair:** The front left planter needs repair.

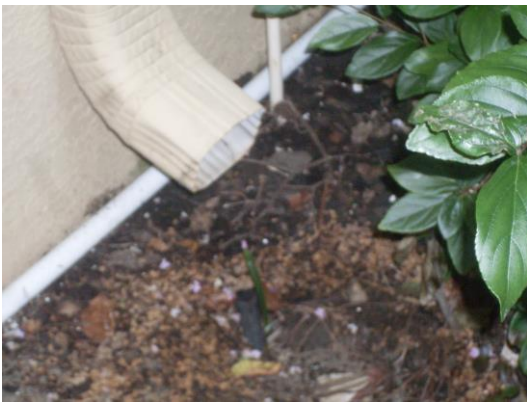
- **Repair:** The gutter downspouts should be extended away from the foundation.

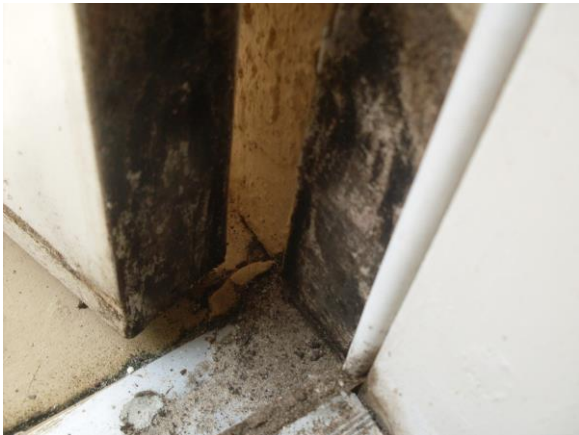
- **Repair:** The garage service entrance door is rusted and the casing decayed.

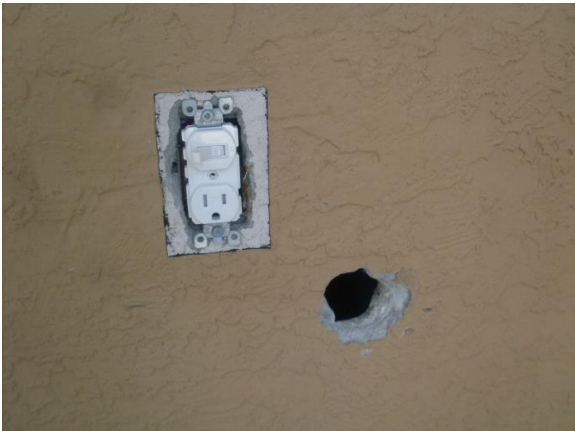
- **Repair:** The hole at the back porch wall needs sealing.

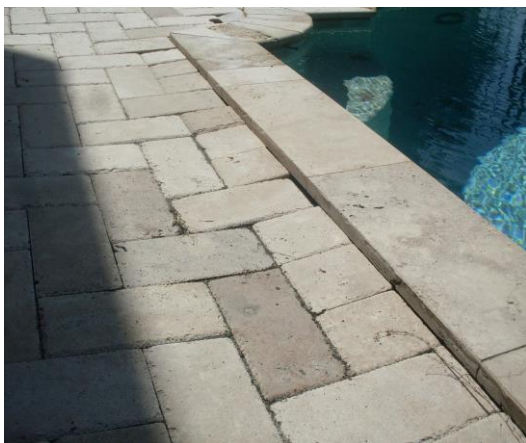
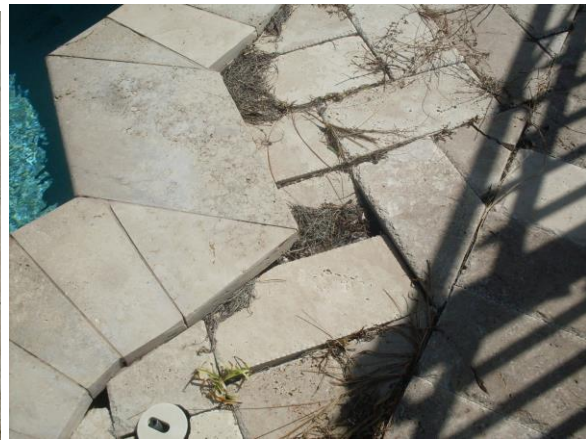
- **Repair:** The pavers at the pool have settled and sunk in various places.

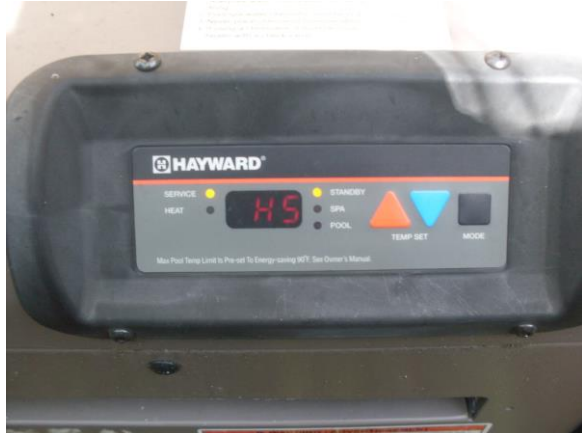
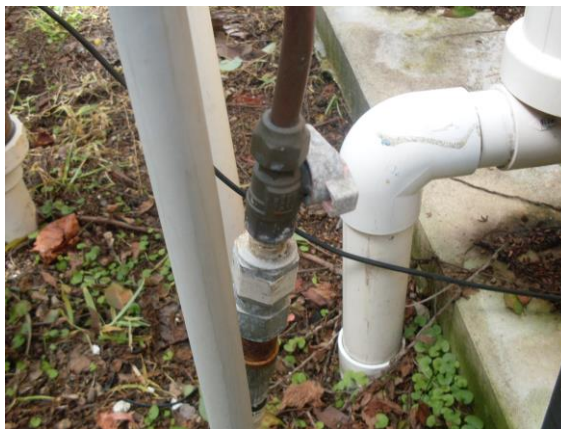
- **Repair:** The gas is off to the pool heater and the control panel did not respond.

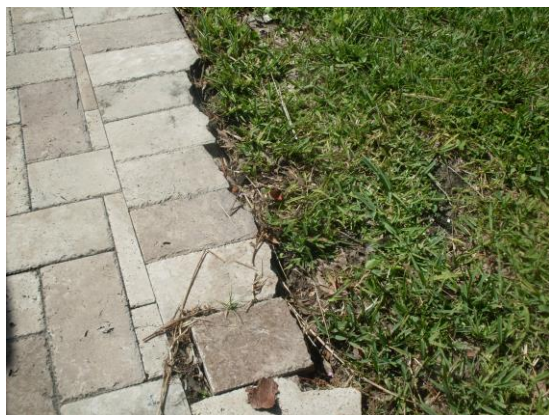
- **Repair:** The pavers are damaged at the driveway.

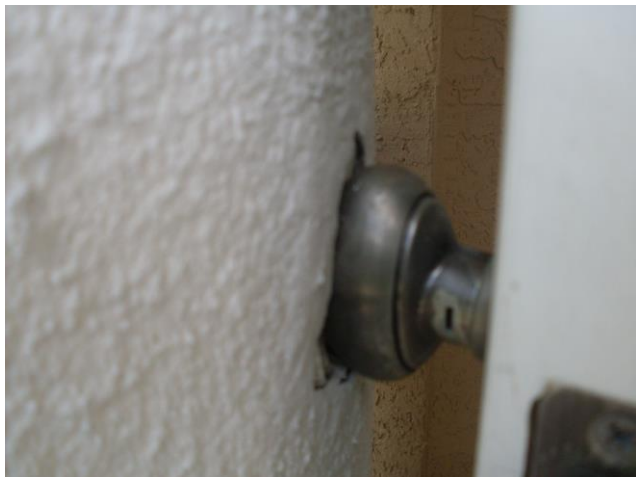
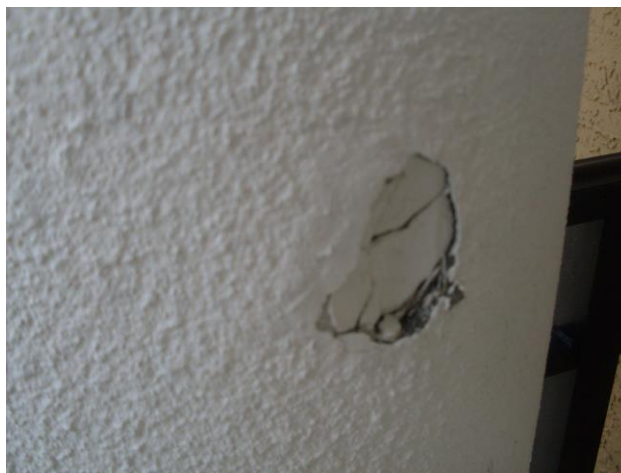
- **Repair:** The pool bath door knob has damaged the back column.

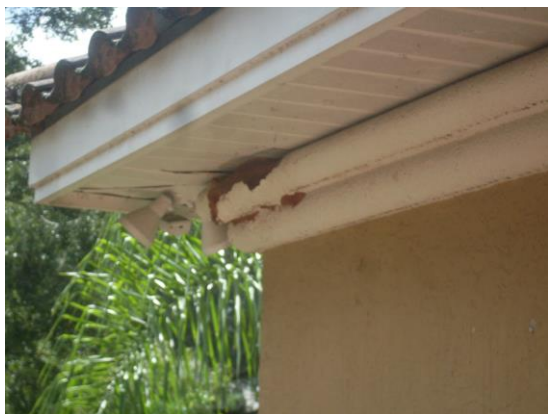
- **Repair:** The decorative cornice is damaged in various places.

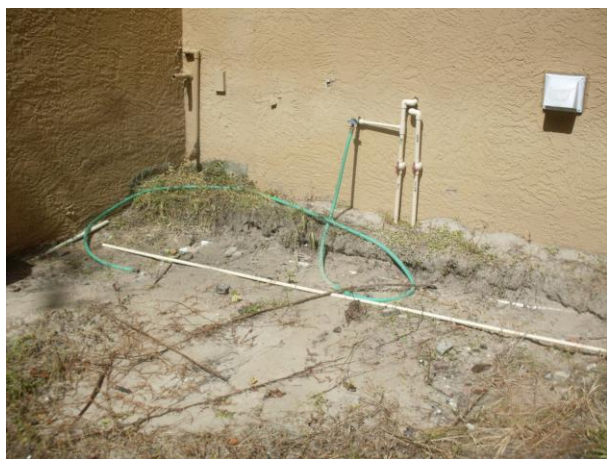
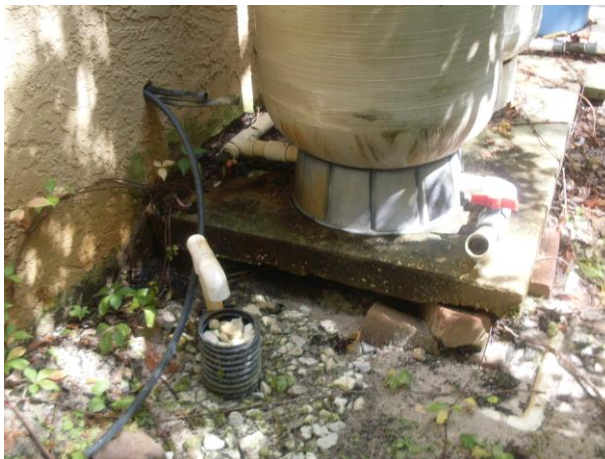
- **Repair:** Erosion was found on the left side of the home.

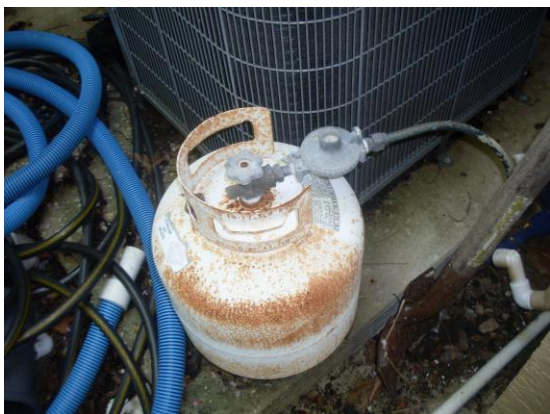
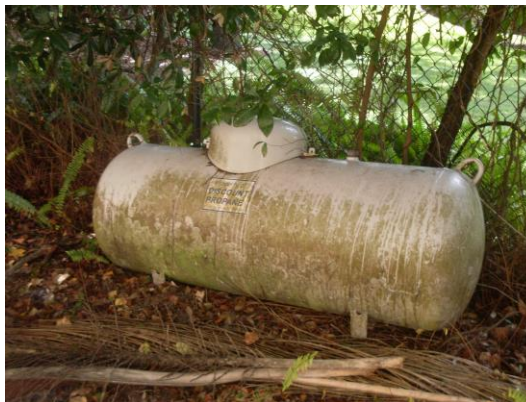
- **Safety:** The propane tank on the left side of the home is not secured and the big one does not appear to be used.

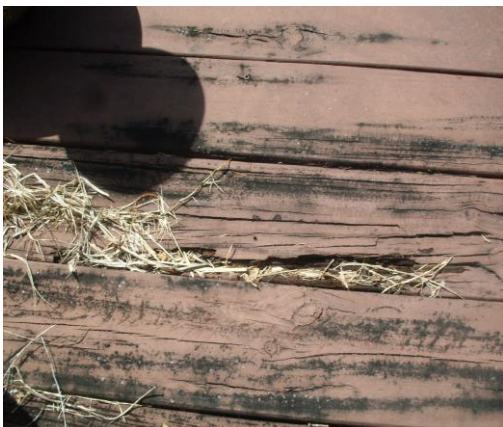
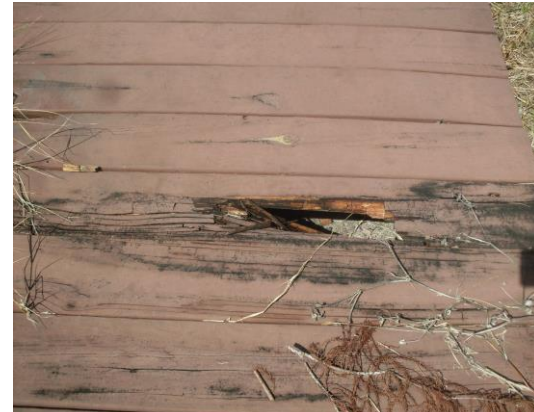
- **Safety:** The dock boards are decayed in various places.

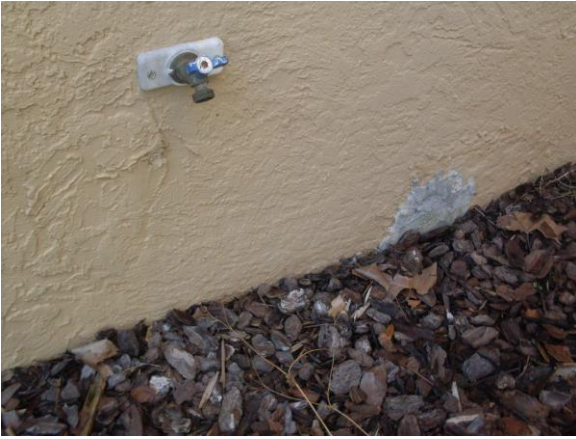
- **Monitor:** Previous repairs were found in the wall to the left of the front entrance.

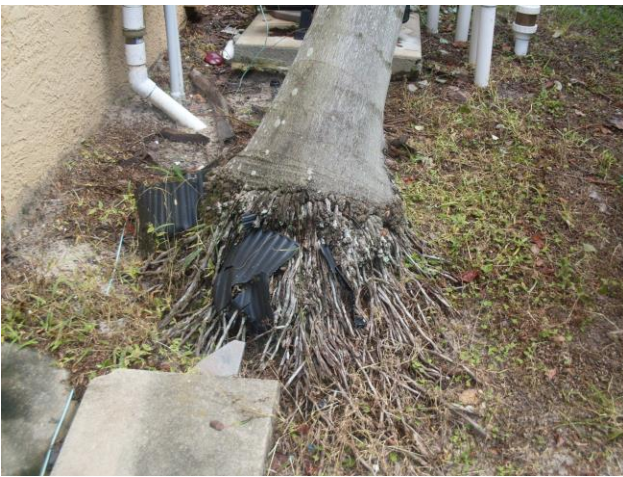
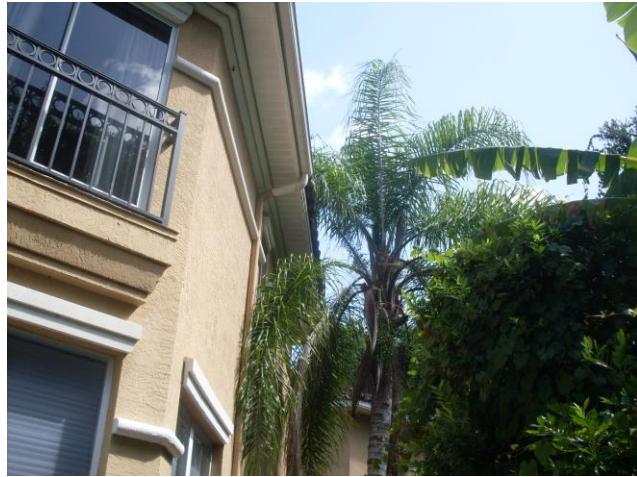
- **Major concern:** The palm tree on the left side of the home is leaning and the roots are partially exposed. The tree is also in proximity to the home and should be relocated.

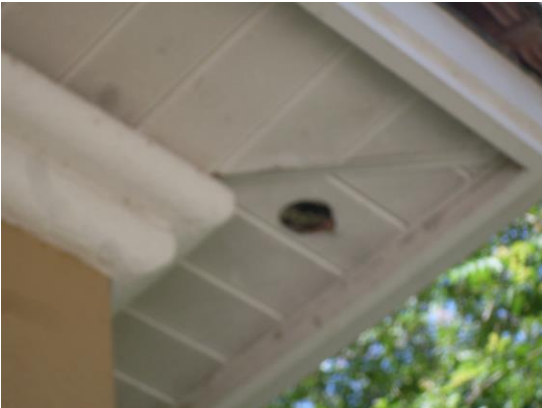
- **Repair:** The light fixture is missing at the front right.

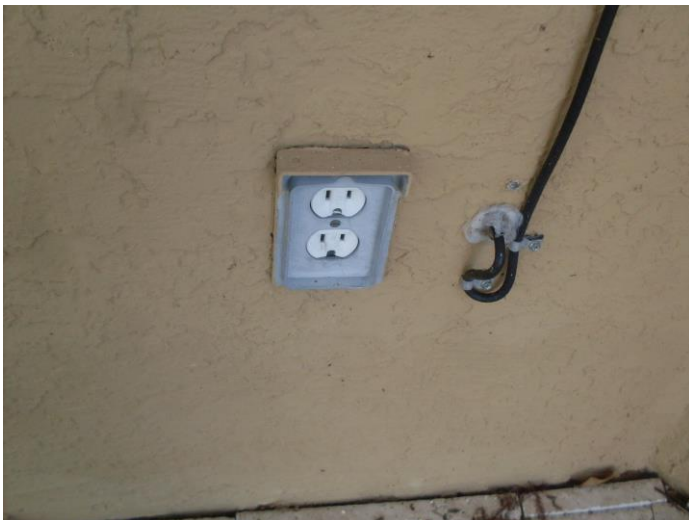
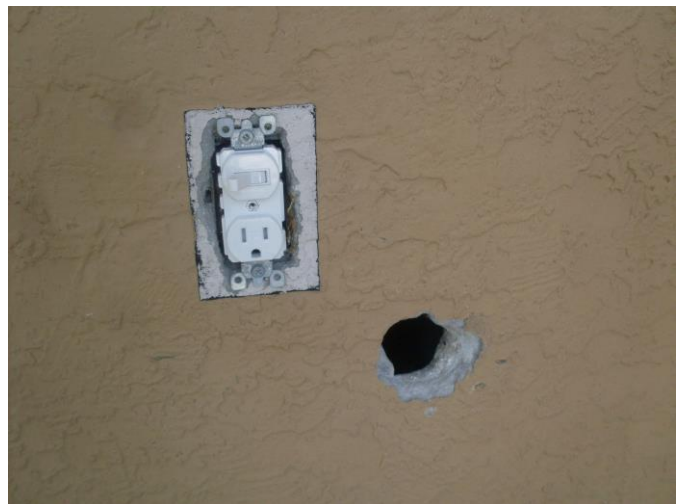
- **Repair:** The back porch outlets are missing weather covers.

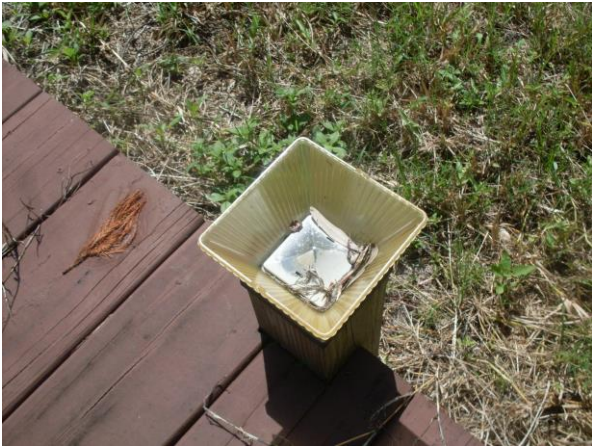
- **Repair:** The lights on the dock are damaged in various places.

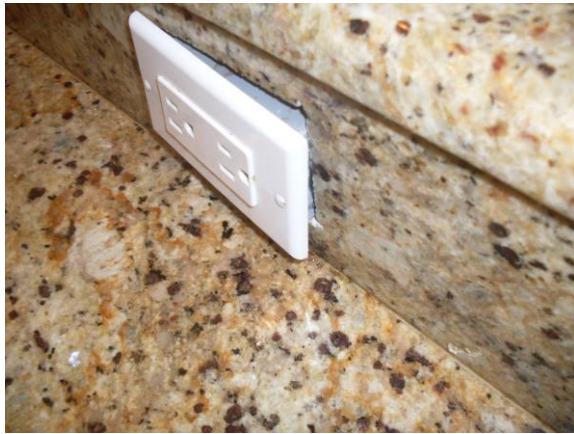
- **Repair:** An outlet at the kitchen backsplash is loose.

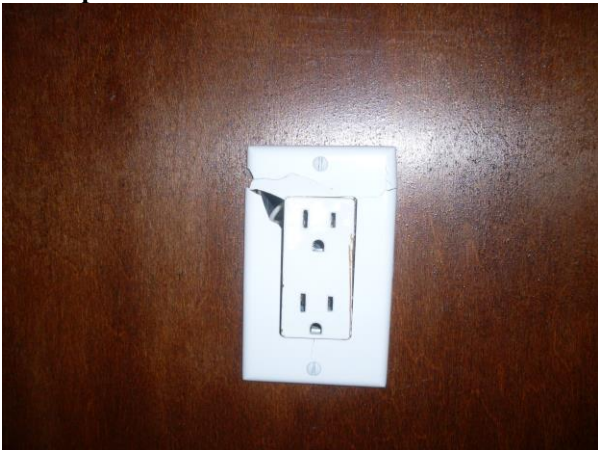
- **Repair:** A broken outlet cover was found in the office.

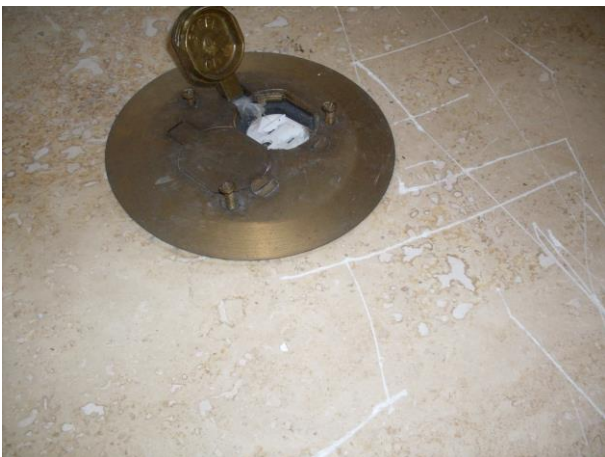
- **Repair:** A living room floor outlet is loose.

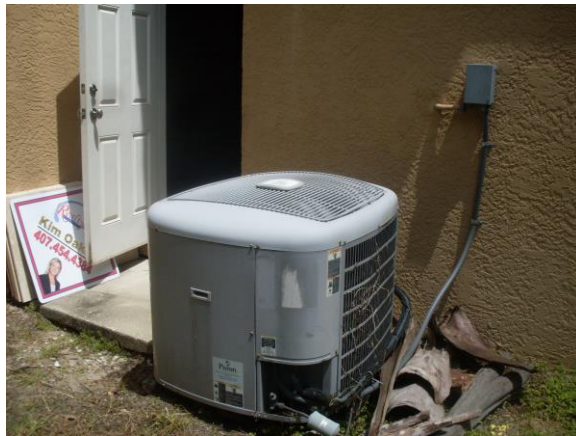
- **Major concern:** The compressor system outside the garage service entrance door does not work. That is for the upstairs system.

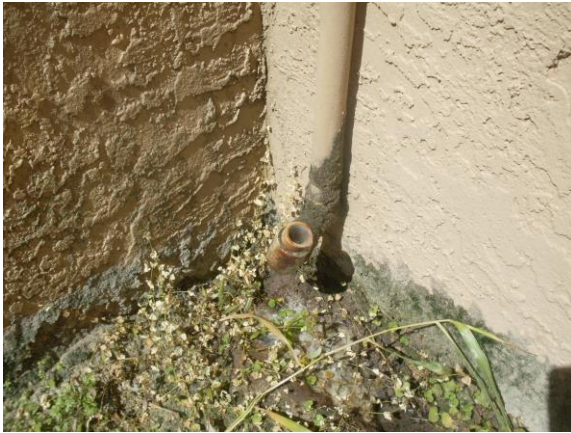
- **Repair:** The AC drain should be extended away from the foundation.

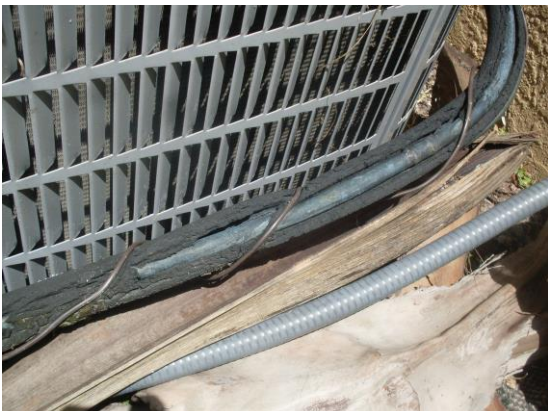
- **Repair:** The ac insulation needs improvement.

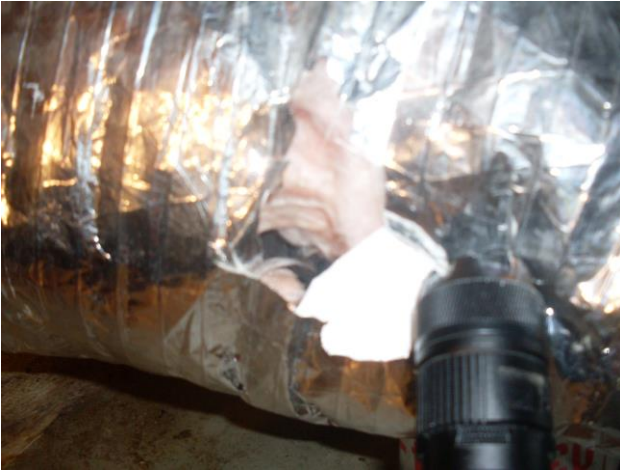
- **Repair:** The ducts in the attic have insulation damage.

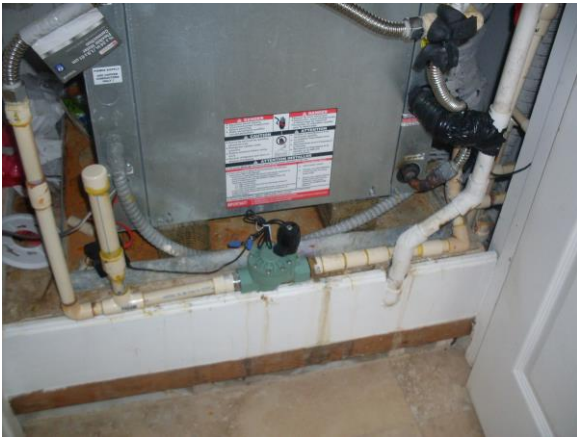
- **Repair:** The temperature drops for the upstairs and right side of the home systems are insufficient or non-existent. The systems need servicing.
- **Monitor:** Previous water staining was found at the air handler.

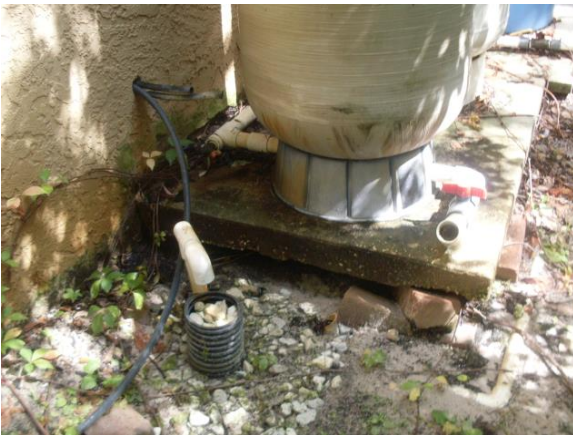
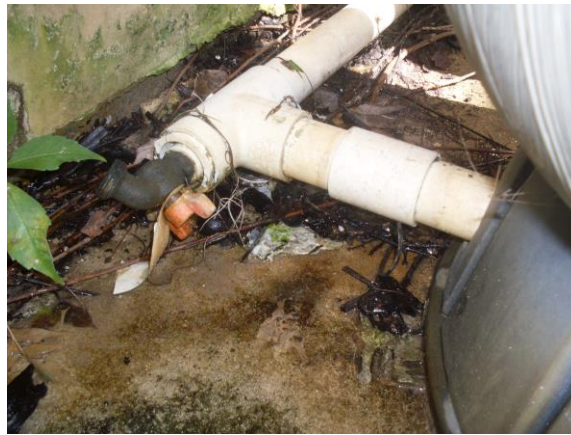
- **Repair:** The equipment appears to leak by the water softener.

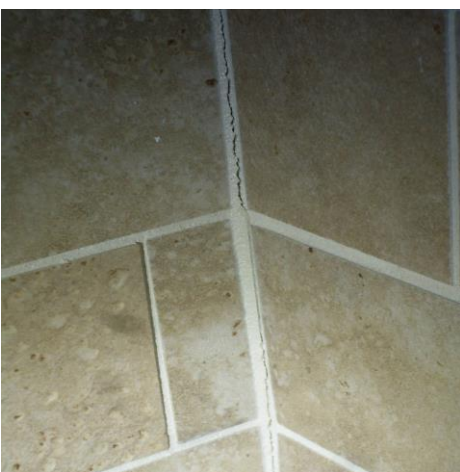
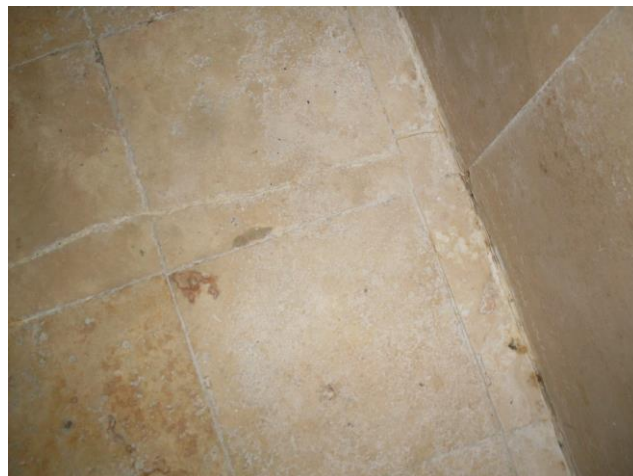
- **Repair:** The master shower tiles are cracked and need caulk/grout.

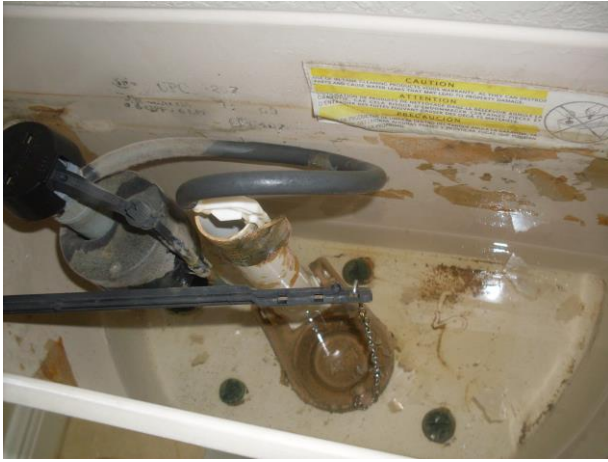
- **Repair:** The master bath toilet tank parts do not function.

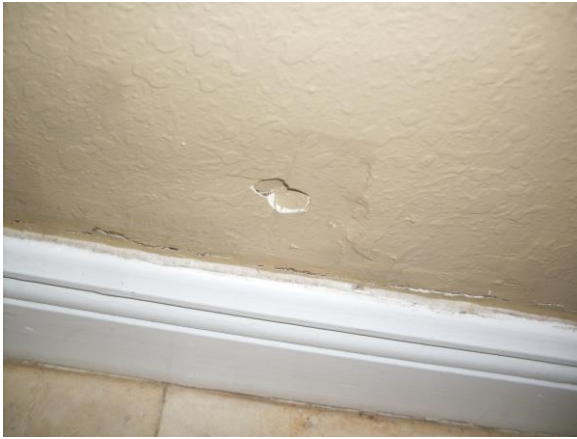
- **Repair:** Wall damage was found in the downstairs half-bath.

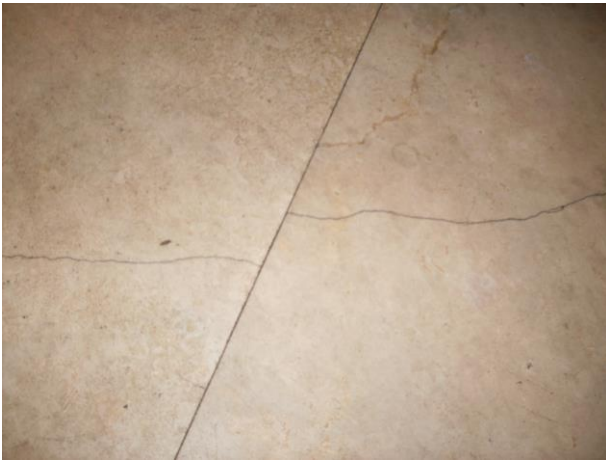
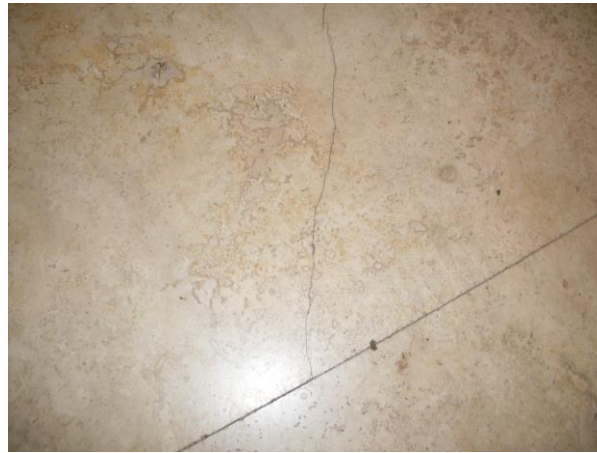
- **Repair:** Cracked tiles were found on the floor in various places.

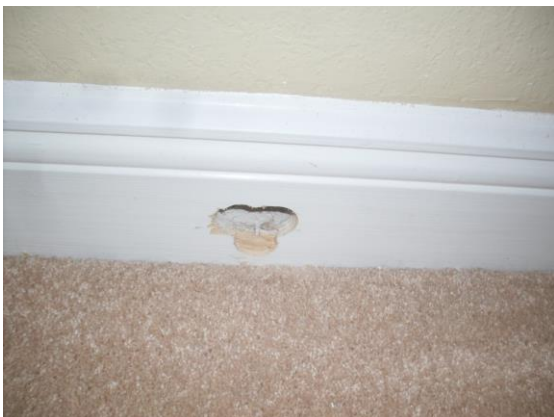
- **Repair:** A bedroom baseboard has holes drilled in it.

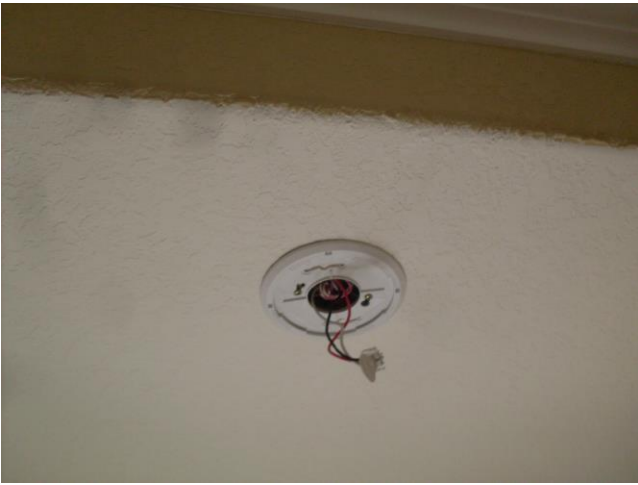
- **Monitor:** All smoke alarms should be checked for functionality and charged batteries as routing home maintenance.

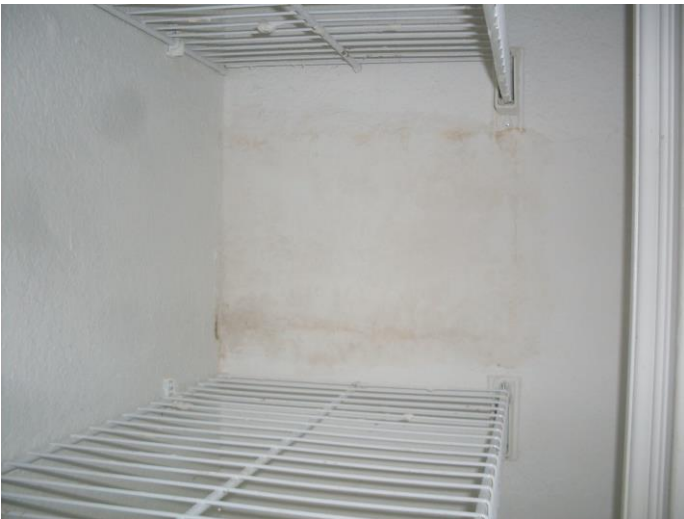
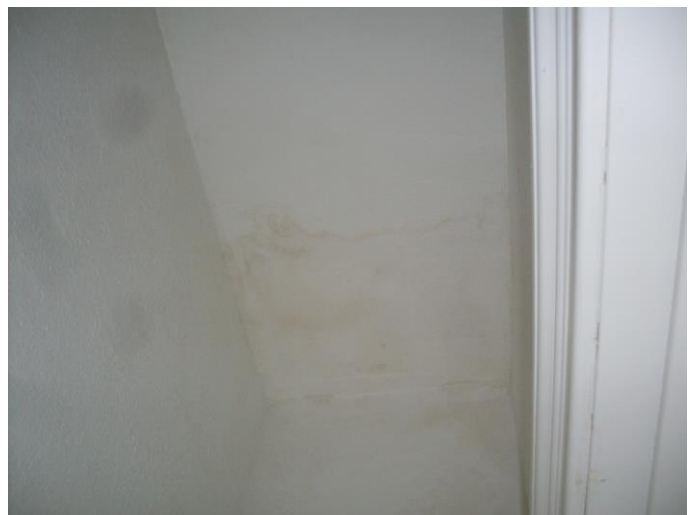
- **Monitor:** Water staining with damage was found in the hall closet by the laundry room.

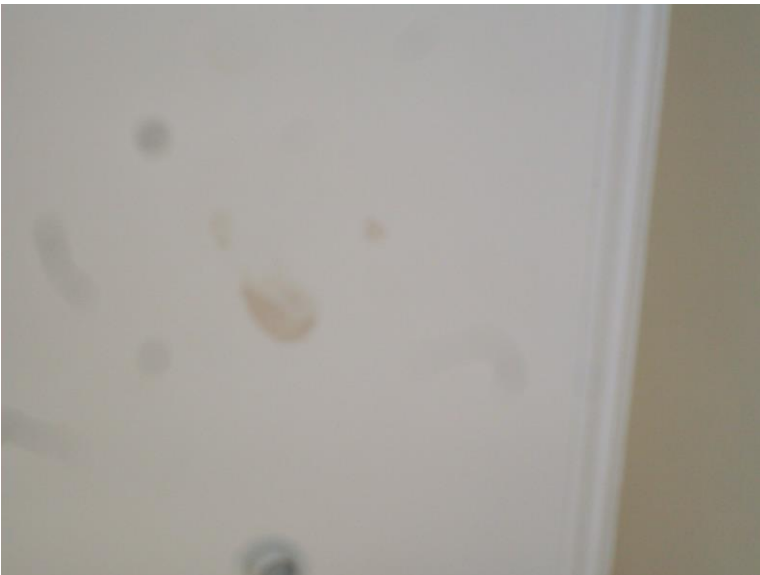
- **Monitor:** Staining was found in the living room ceiling.

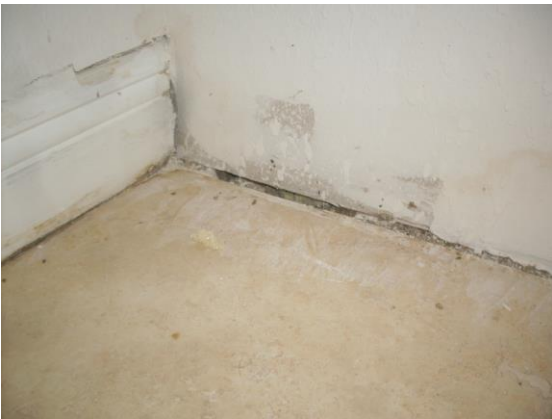
- **Repair:** A missing piece of baseboard was found in the bathroom.
