Building Inspection Report

XXXXXXXX XXXXX XXXXX , FI

Inspection Date:
XXX.XX, XXXX

Report Number:
XXXXXXXXXX

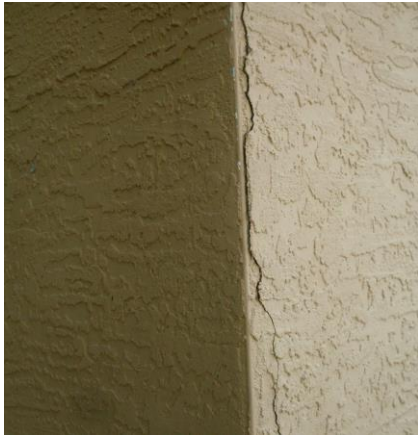
- **Major concern:** Stucco damage was found at the back right of the home.

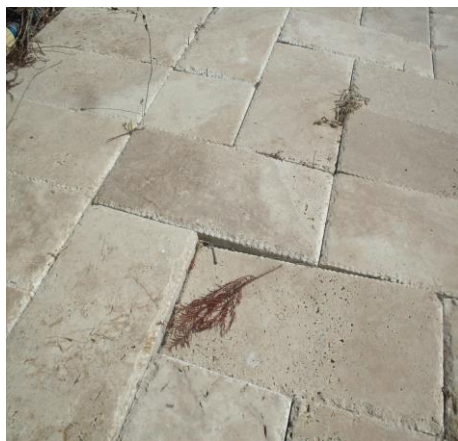
- **Repair:** The pavers at the pool have settled and sunk in various places.

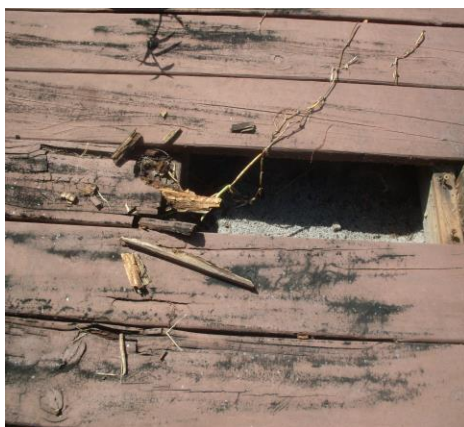
- **Safety:** The dock boards are decayed in various places.

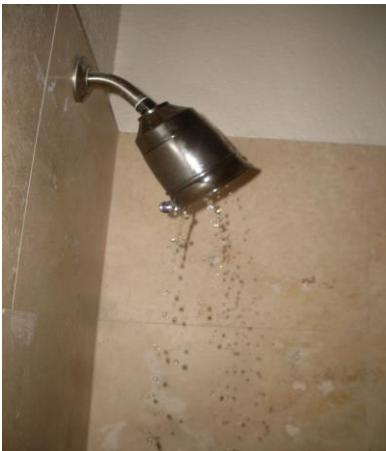
- **Repair:** The master bath shower water pressure is very low.

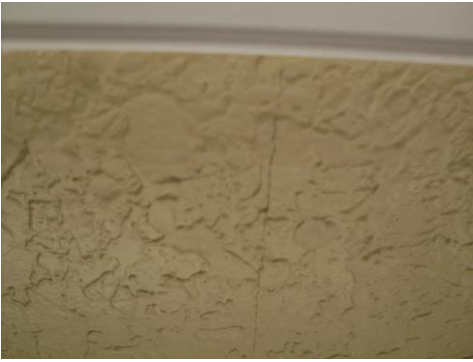
- **Monitor:** Typical drywall flaws were found in various places.
